# Survey of Metal Contamination in DIII-D Plasma Facing Tiles with Beta Backscattering and XRF

Presented 06/22/12

2012 PFC conference in at PPPL, Princeton, NJ

# Unusually high levels of metal impurities impeded high performance operation on DIII-D in 2011

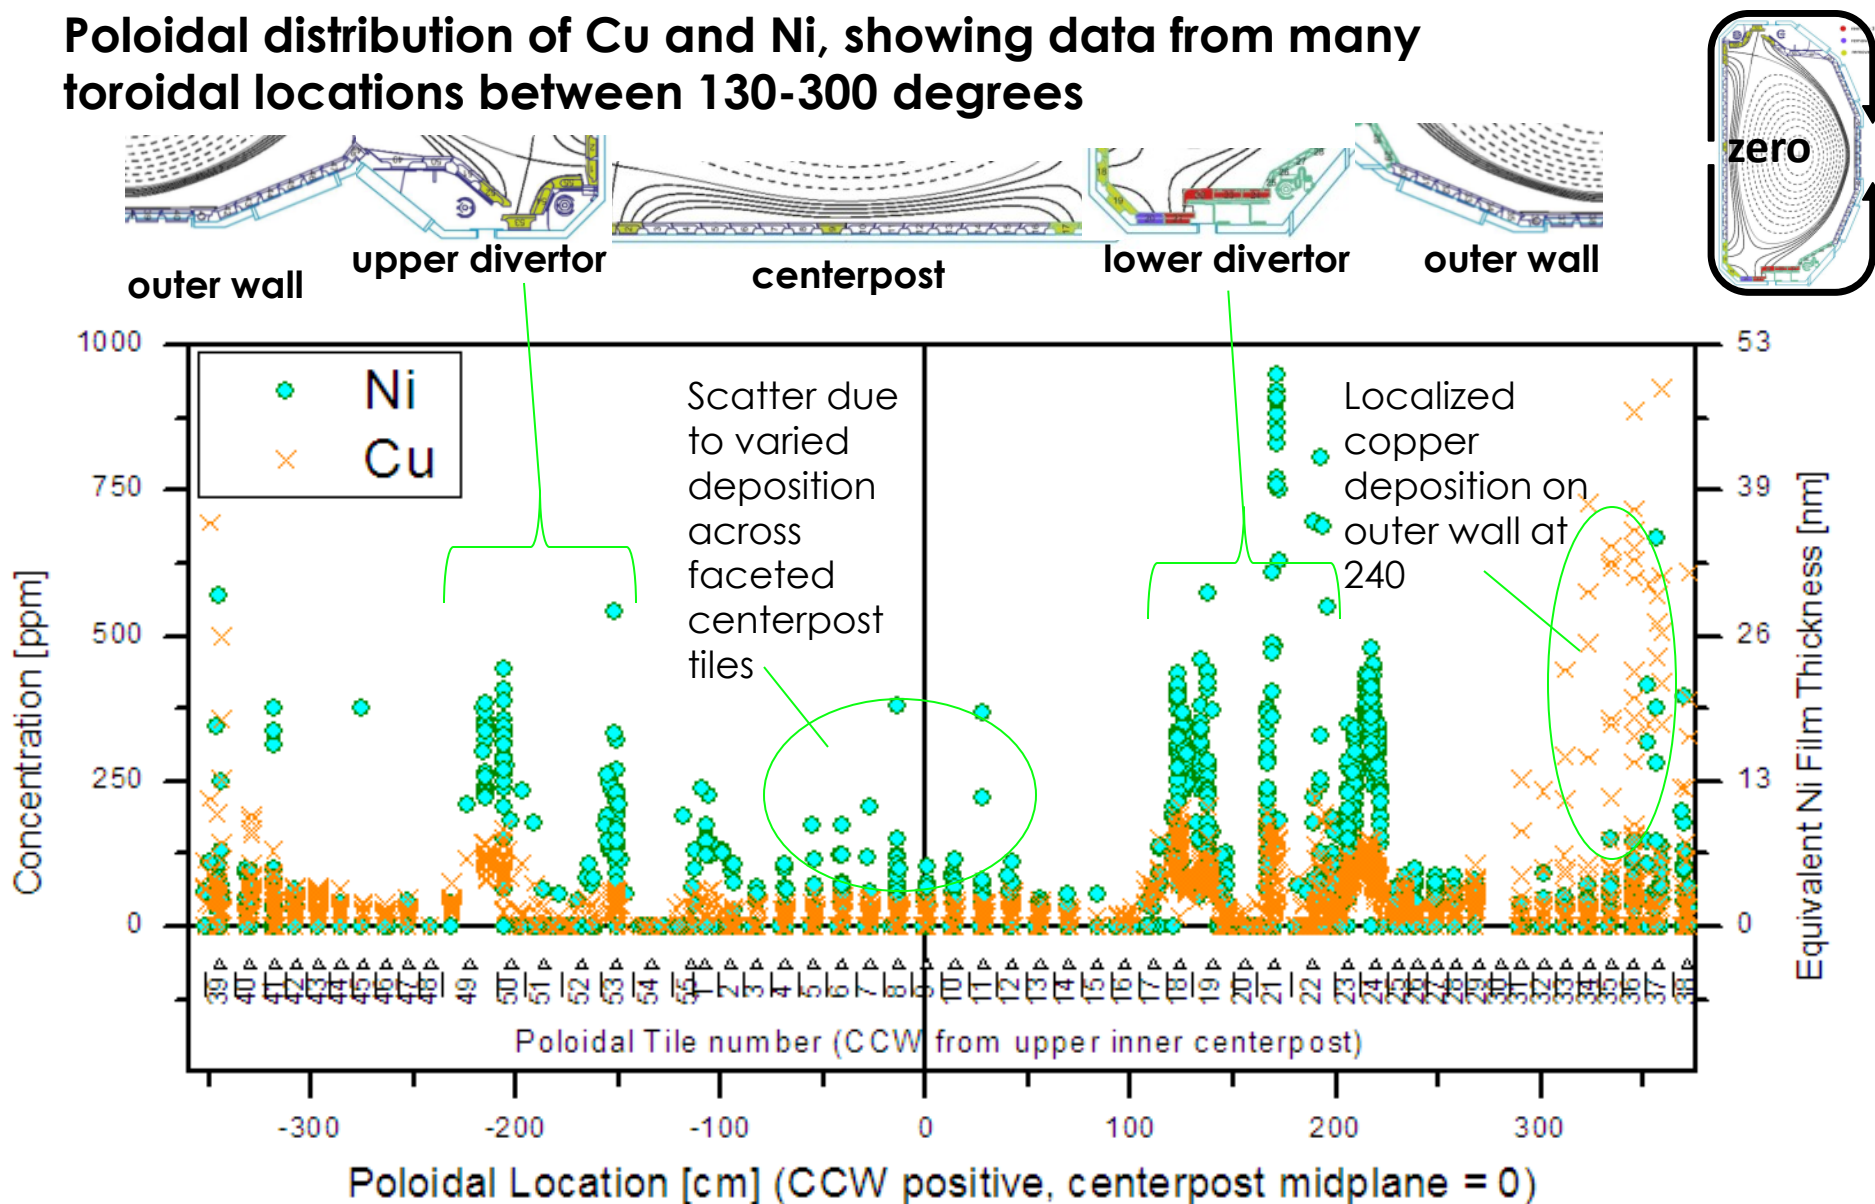
# Poloidal distribution shows metal deposition is largely localized near divertor regions

Poloidal distribution of Cu and Ni, showing data from many toroidal locations between 130-300 degrees

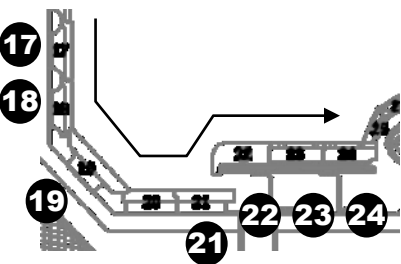
Equivalent to pure nickel film between 50-150nm thick

BB is not element-specific

Film thickness 4x higher than XRF estimates for Cu and Ni, partly due to presence of Fe, Cr, and other metals

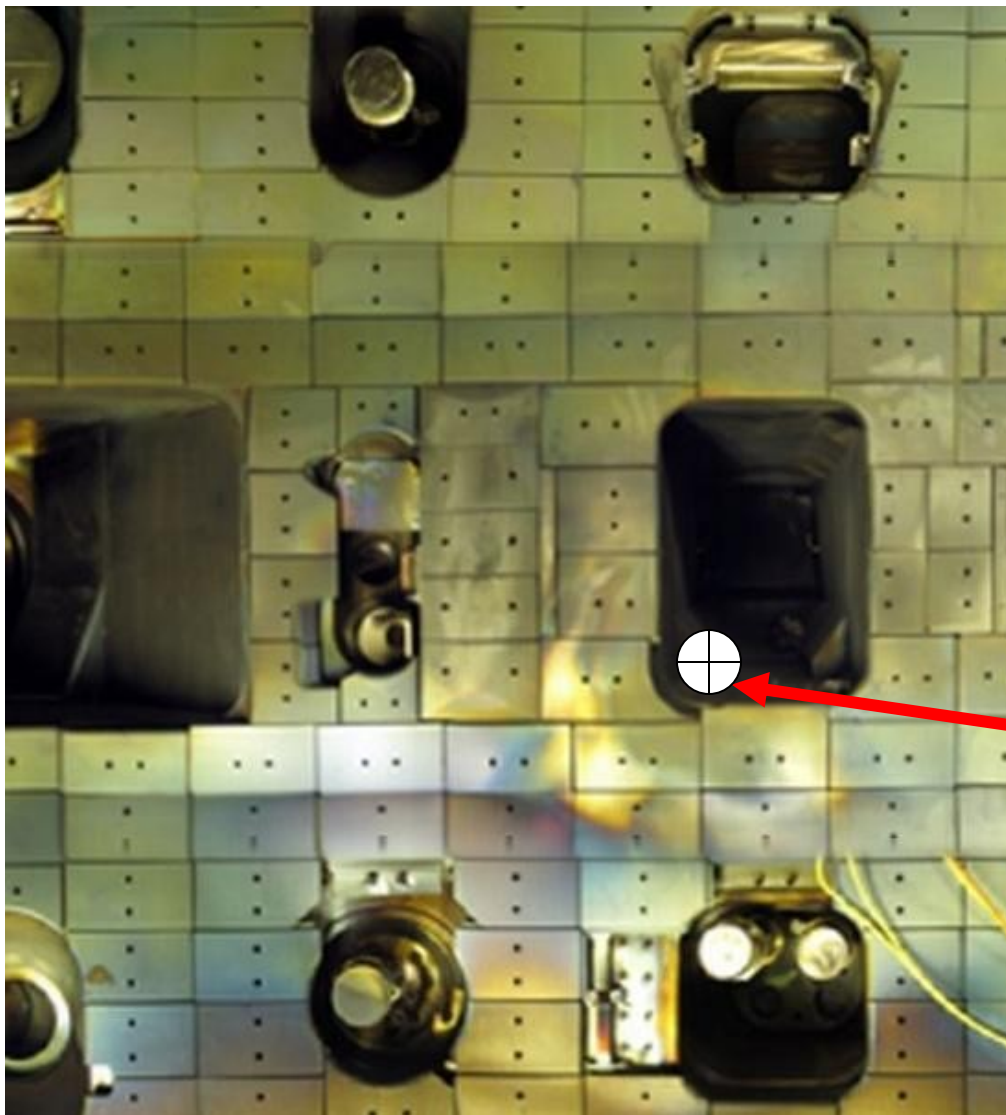
# Dec 2011 vessel inspection found bright-colored region near 240-degree outer wall midplane

XRF analysis verified presence of copper in colored region.

Source of copper vapor deposit *and* nickel splatter was later found to be from a reciprocating midplane probe that was damaged by runaway electron beam.

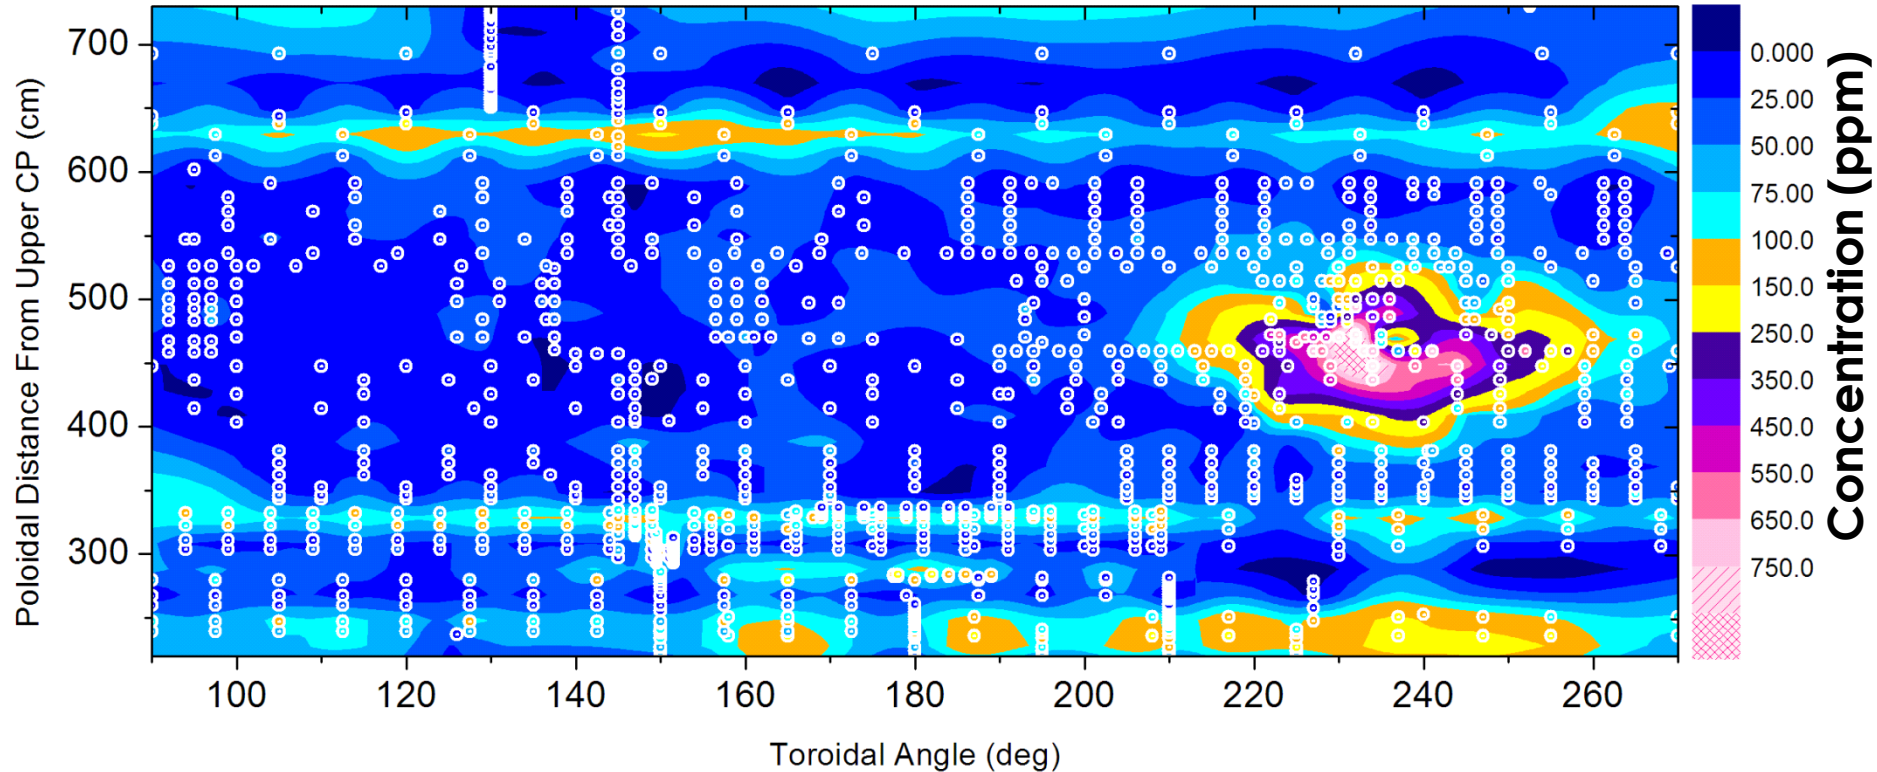
Main copper deposit near 240-degrees due to midplane probe damage  
Upper and lower outer shelf, and upper and lower centerpost are toroidally symmetric deposit regions

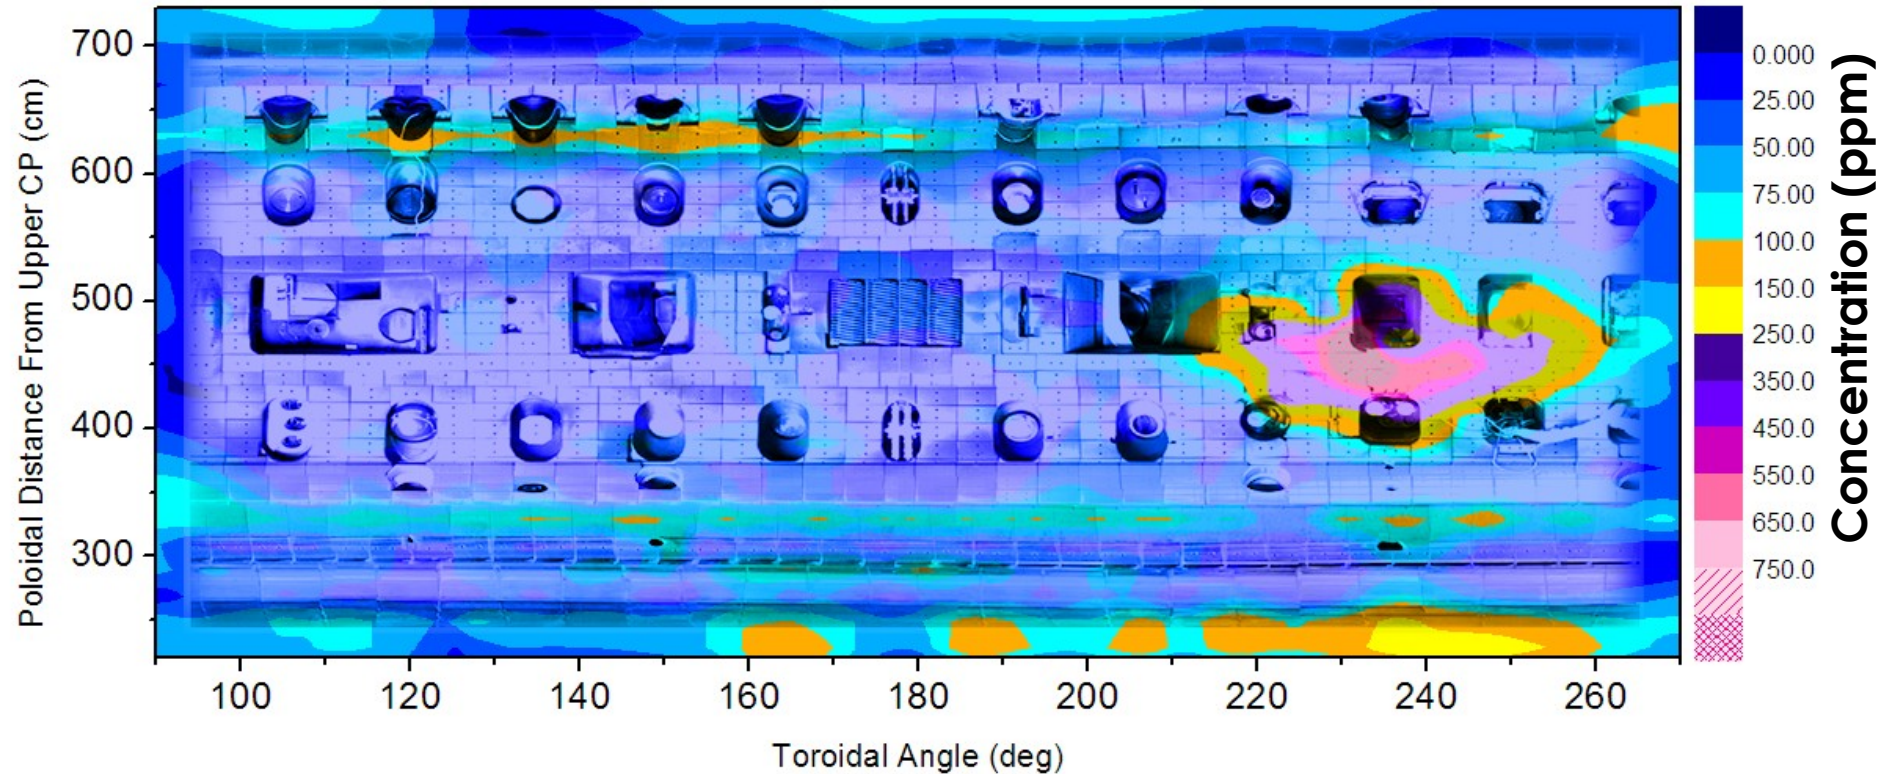
Main copper deposit near 240-degrees due to midplane probe damage  
Upper and lower outer shelf, and upper and lower centerpost are toroidally symmetric deposit regions

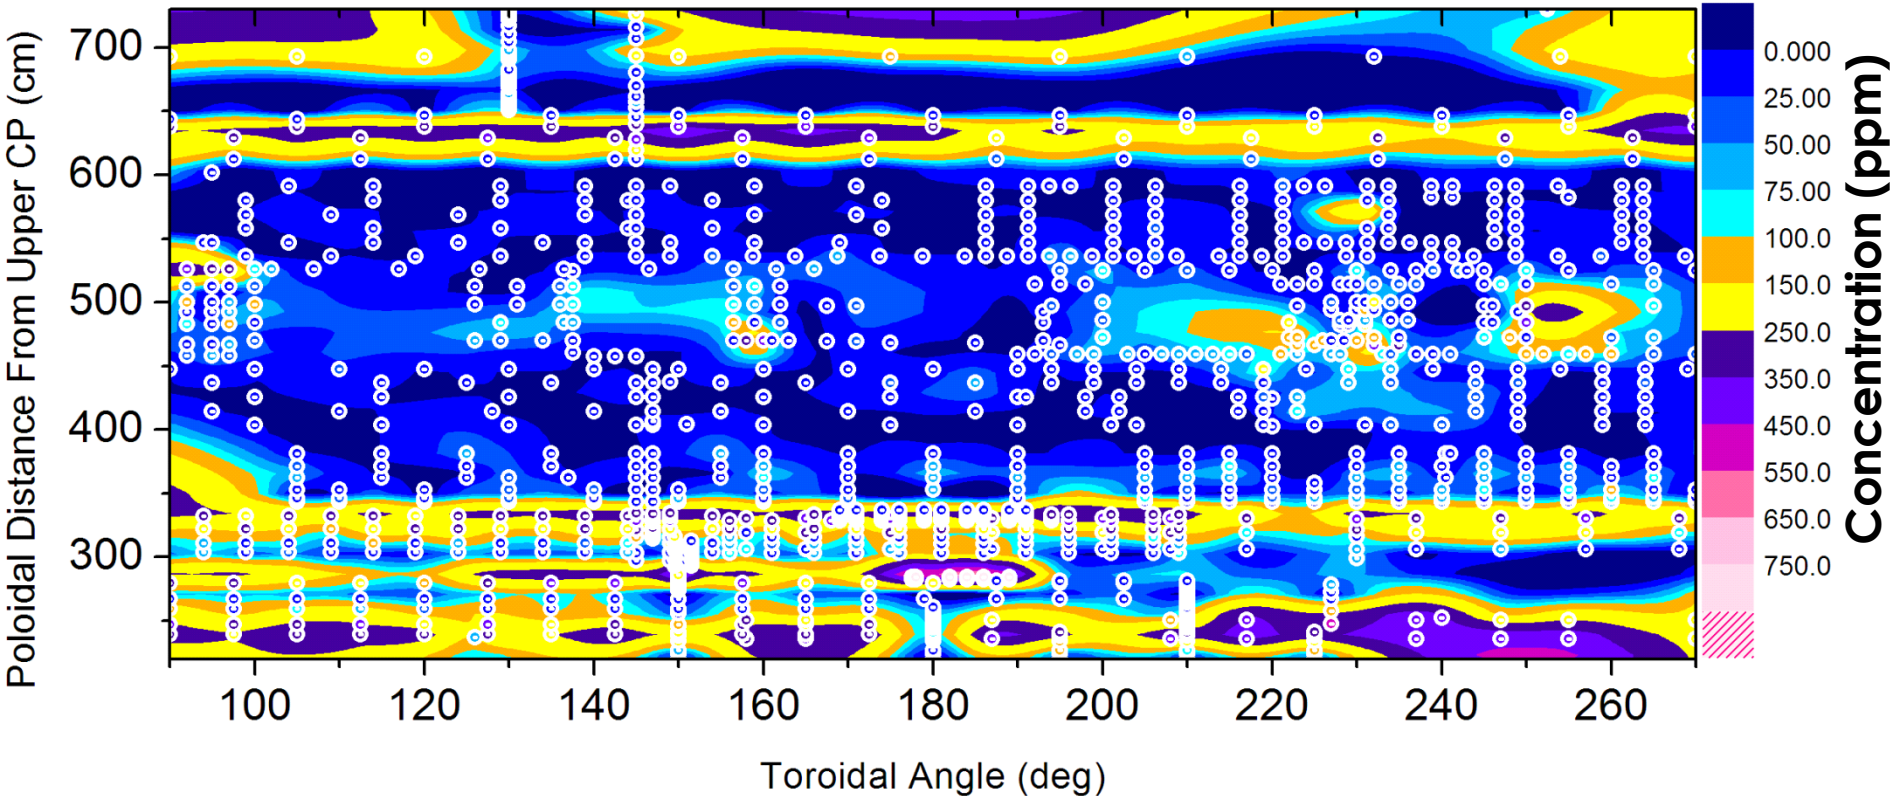
Main nickel deposit are in upper and lower divertor, shelf, and centerpost regions. Some scattered areas in the outer wall show above background. Toroidal bumper limiters only slightly above background.

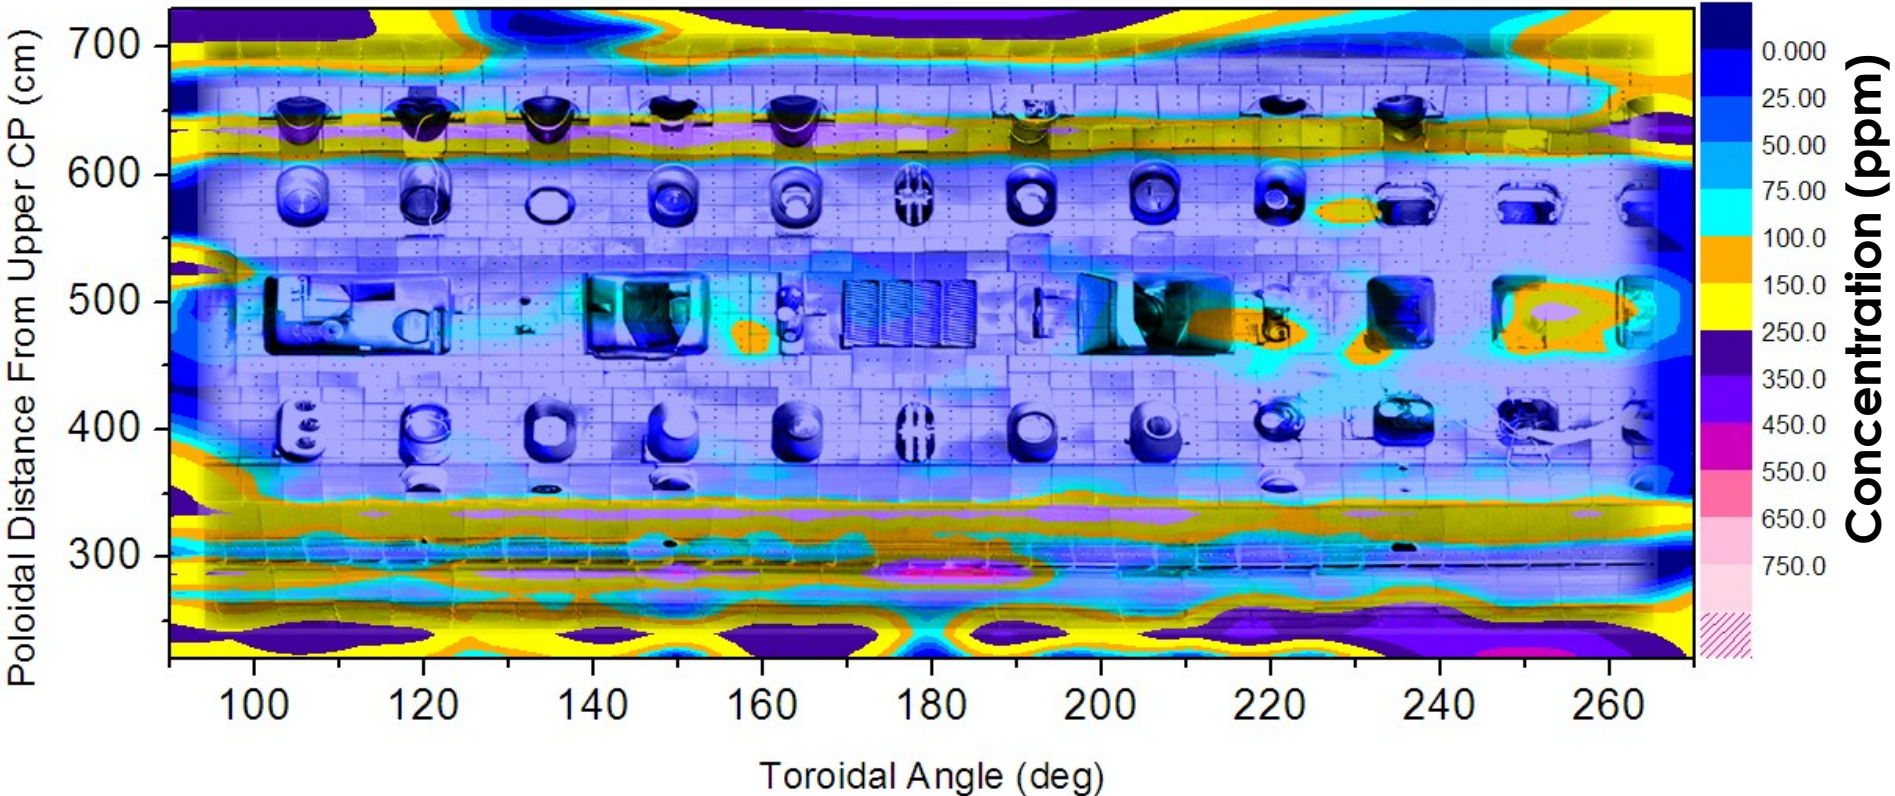
Main nickel deposit are in upper and lower divertor, shelf, and centerpost regions. Some scattered areas in the outer wall show above background. Toroidal bumper limiters only slightly above background.

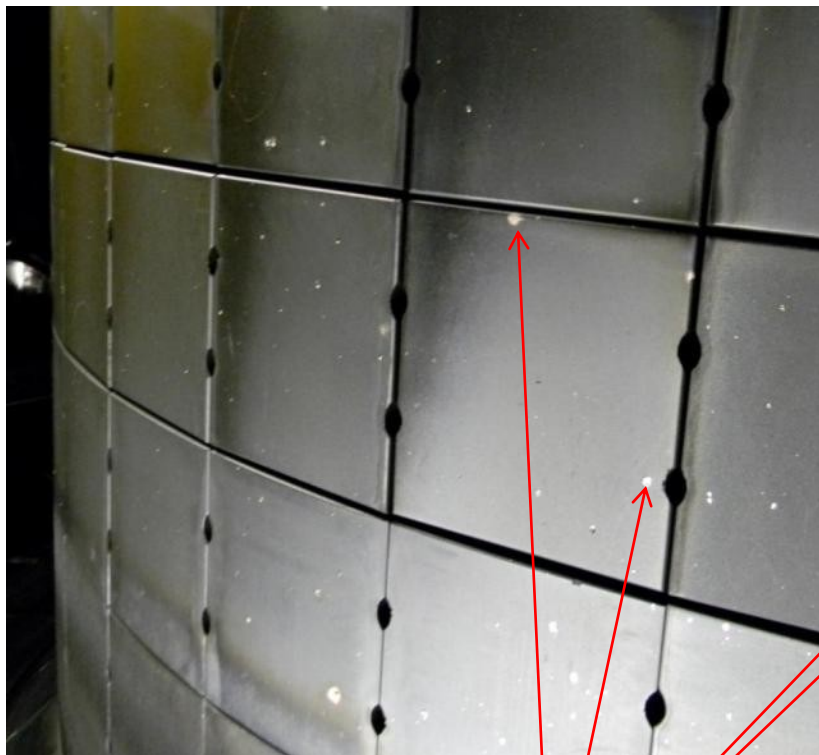
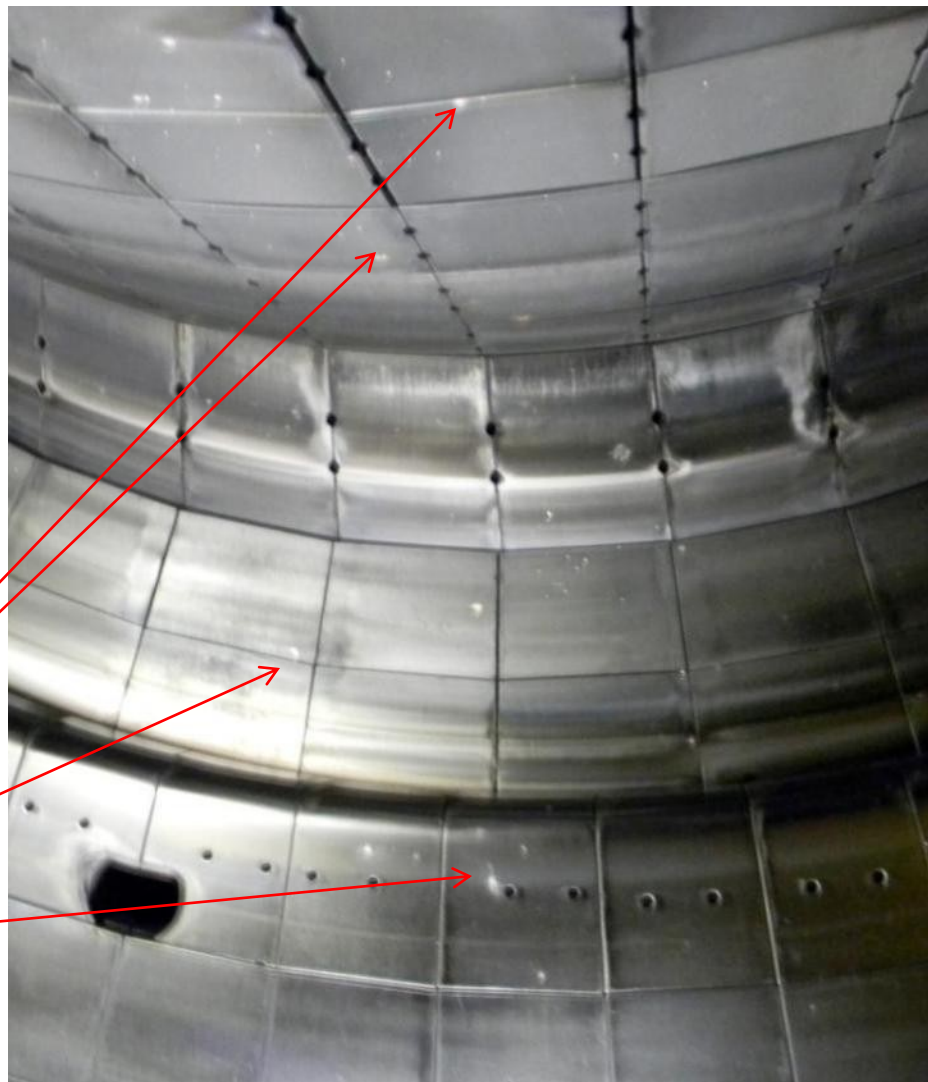
# Sept 2011 Vessel Inspection Found Metal Splatter on Centerpost between 220-250 degrees

Inconel fragments removed with a simple scraping tool

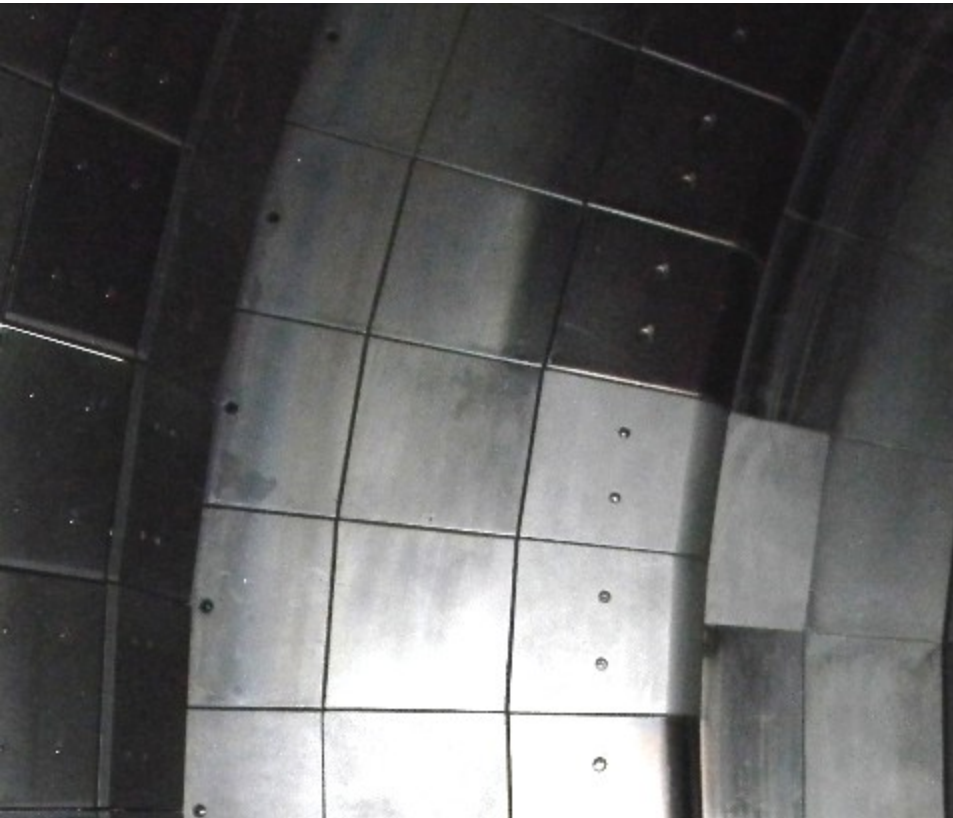
2010

# Lower divertor had unusual striping, discoloration, and pronounced arc track erosion on outer shelf

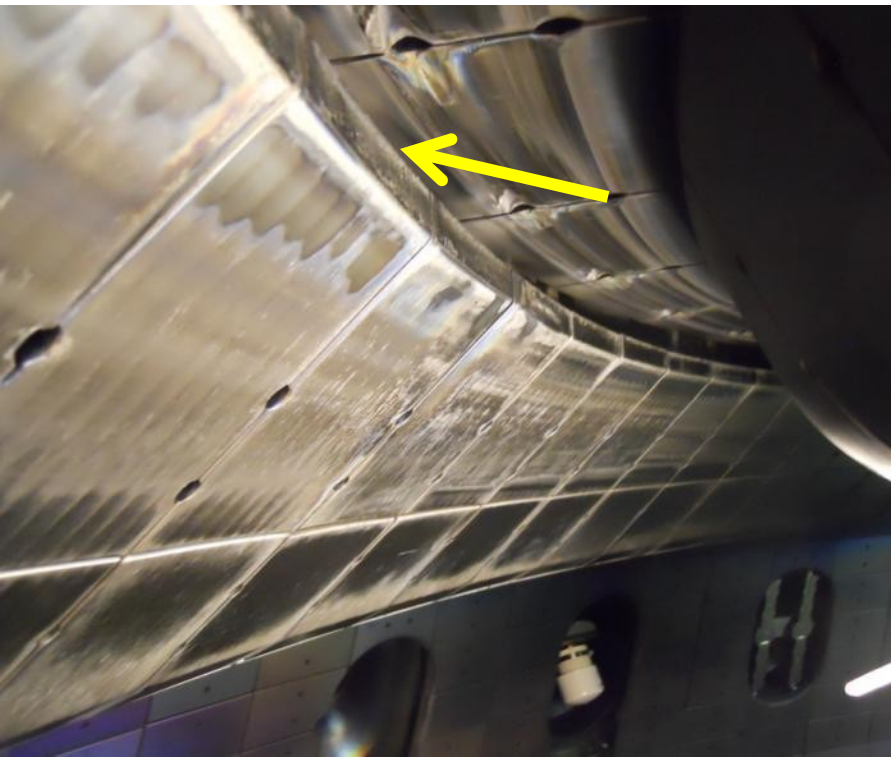
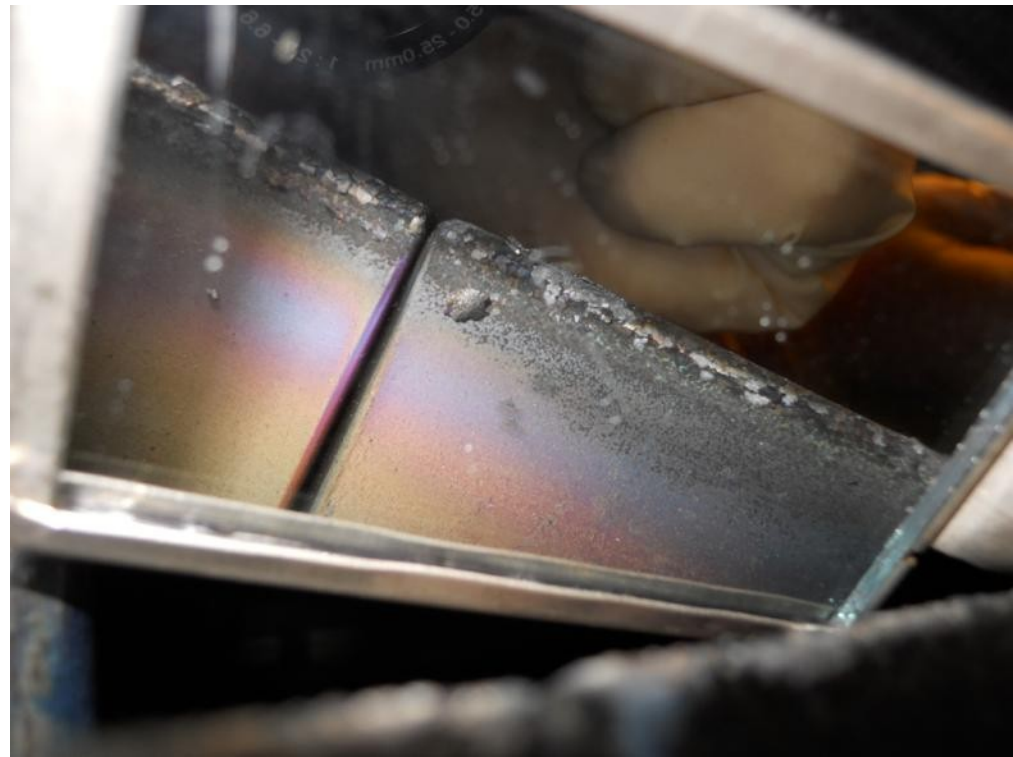
# Upper divertor has massive erosion at bolt hole edges, as well as flaky deposits

Deposits exfoliating in large flakes, resting gently on upper surface of baffle tile.

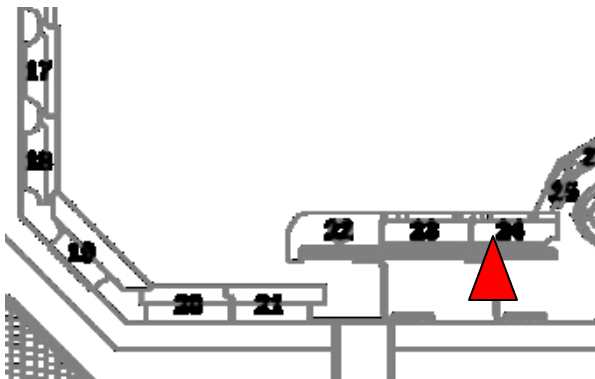
Measurements taken around outer lower shelf, on Tile 24.

Additional scatter in the data can be due to measurements on and off arc erosion tracks.
