# Survey of Metal Contamination in DIII-D Plasma Facing Tiles with Beta Backscattering and XRF

Presented 06/22/12

2012 PFC conference in at PPPL, Princeton, NJ

# Unusually high levels of metal impurities impeded high performance operation on DIII-D in 2011

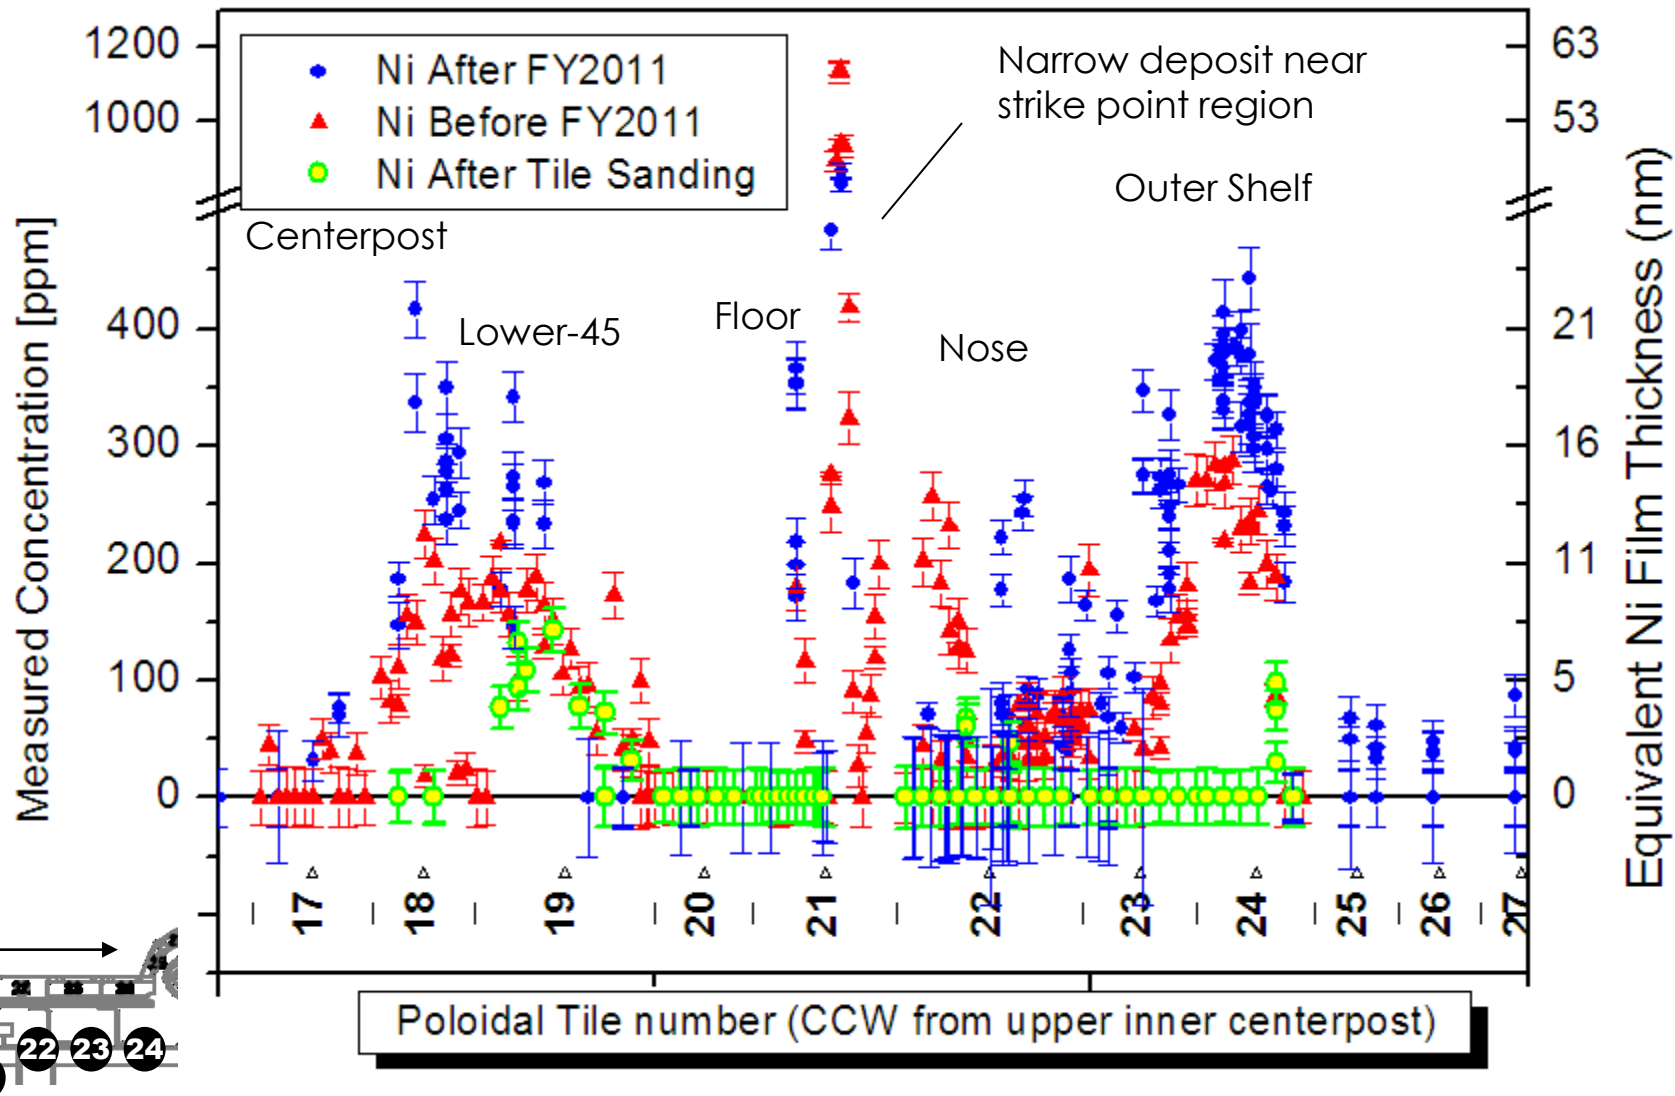
# Lower Divertor Detail – Nickel

XRF survey results – 130 to 175 degrees poloidal

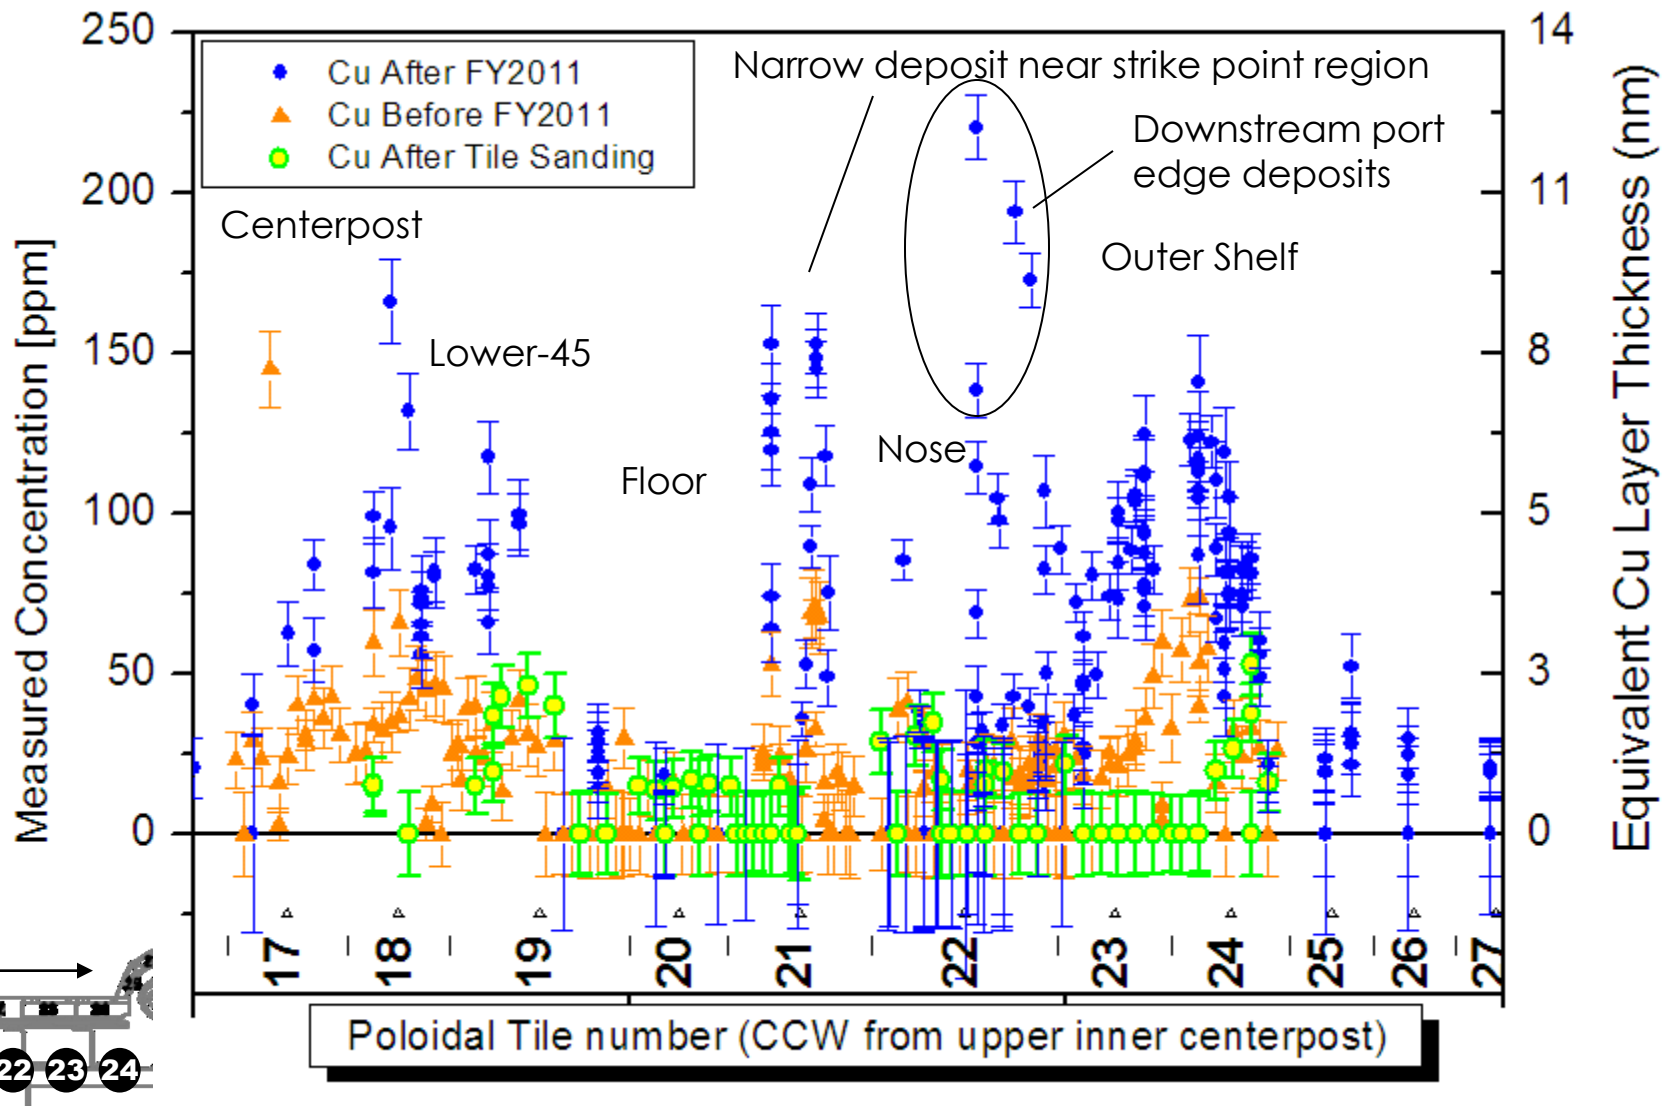
# Lower Divertor Detail – Copper

XRF survey results – 130 to 175 degrees poloidal

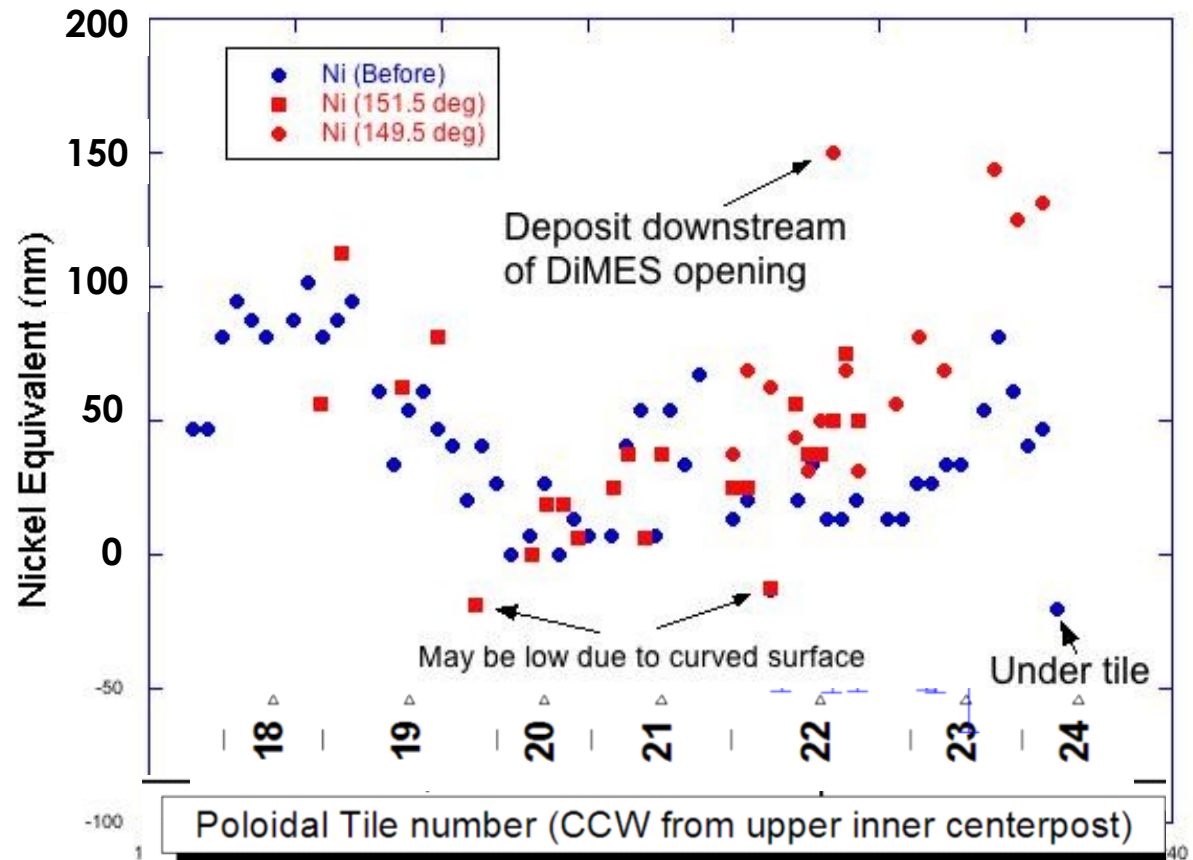
### Comparison of Before and After 2011 Campaign

Equivalent to pure nickel film between 50-150nm thick

BB is not element-specific

Film thickness 4x higher than XRF estimates for Cu and Ni, partly due to presence of Fe, Cr, and other metals

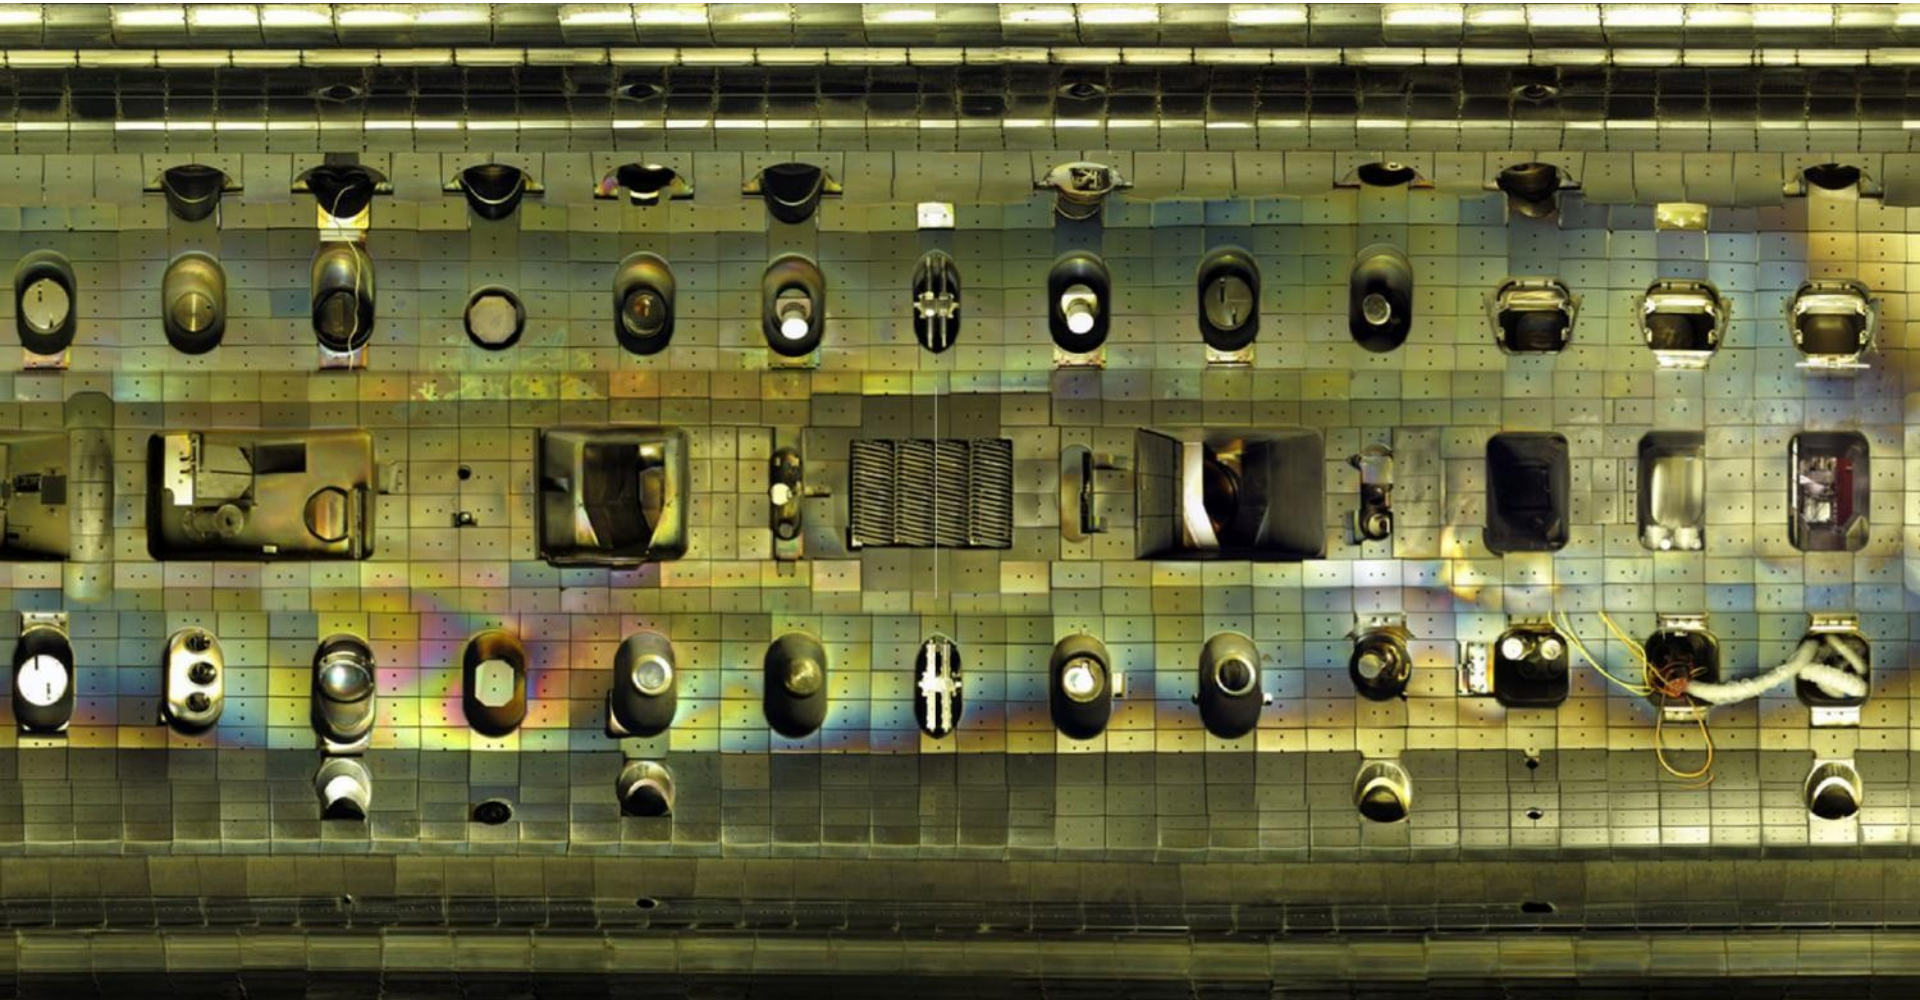
# 2-D vessel outer wall and divertor area surveyed by XRF from 90 to 270 degrees

Panoramic view of outer wall, upper and lower divertors

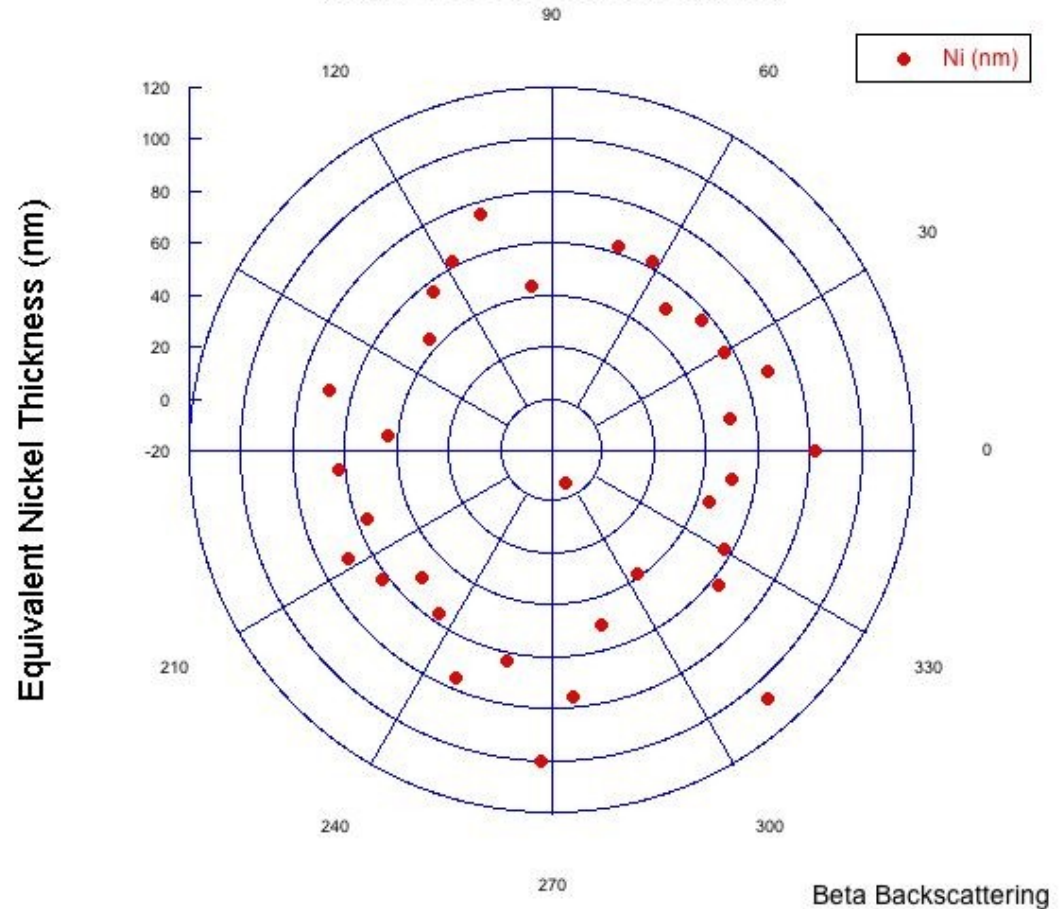
Metals on Lower Divertor  
Toroidal Scan of Outer Shelf  
(High Co-Deposition Region)

Measurements taken around outer lower shelf, on Tile 24.

Additional scatter in the data can be due to measurements on and off arc erosion tracks.
